**COMMISSION FOR
HISTORICAL & ARCHITECTURAL
PRESERVATION**

STAFF REPORT

REQUEST: Demolition Hearing One – Determination of Architectural Significance

ADDRESS: 1326 Hollins Street – Rear/1327 Booth Street (Union Square Historic District)

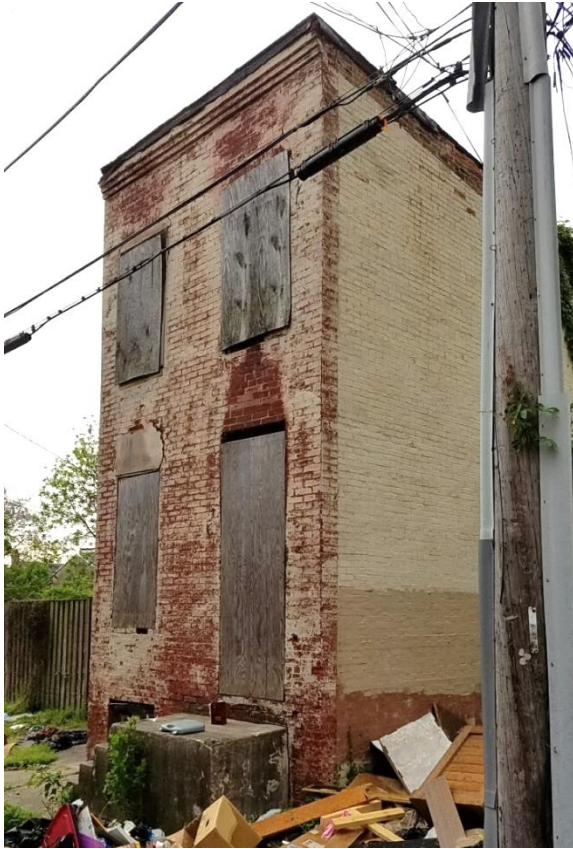
Site Conditions/Architectural Description: The building is located on the south side of Booth Street not far from S. Calhoun Street. It is a single masonry two-story two-bay alley house with a basement window and five concrete steps leading to the front door. The window and door openings are boarded. The second floor windows have brick lintels; the lintel over the first floor window appears to have been patched over. The masonry is covered in peeling paint. A brick cornice is at the roof edge; the sides have no windows (*Images 5-7*). The rear—the portion facing the rear yard of 1326 Hollins Street—is enveloped in heavy vegetation. The rear openings mimic the Booth Street side, but these openings are not boarded, so the building is open to the weather (*Image 8*). The rear wall and the east wall appear to have been stuccoed, but it is in poor repair. The west wall is painted. A fire damaged the building at some point. CHAP files don't record when the fire occurred, but it has had this appearance for more than ten years, as can be seen in a December 2007 Google Street View (*Image 9*). A pair of attached two-story alley houses, located to east, to the Carey Street end of the block are the only two other two-story structures on this side of the street (*Image 10*). The north side of Booth Street

Image 7: 1327 Booth Street, May 10, 2018

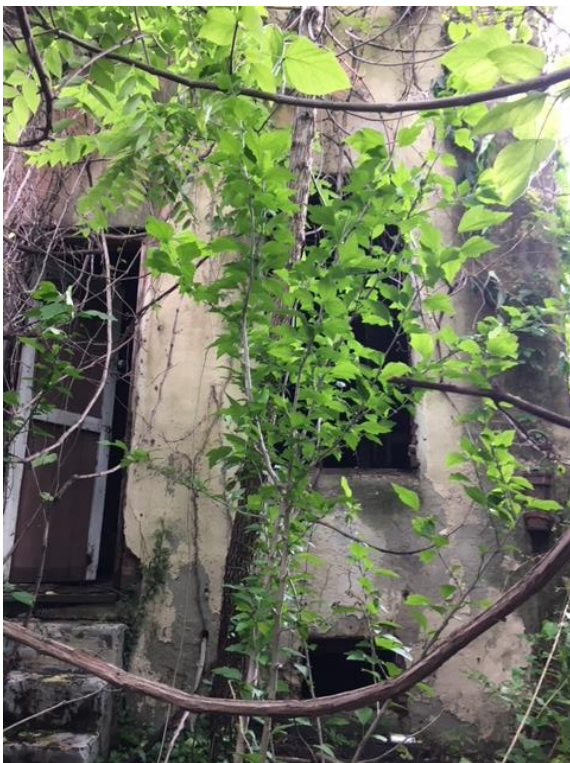
...I understand that the interior framing has collapsed, thus allowing moisture to do further damage. The front and west walls are mostly visible and their exterior face brick is in reasonable condition. The east wall is covered with parging and the brickwork is not visible. The rear of the building is encased in vegetation...

Image 8: 1327 Booth Street, rear, June 4, 2018

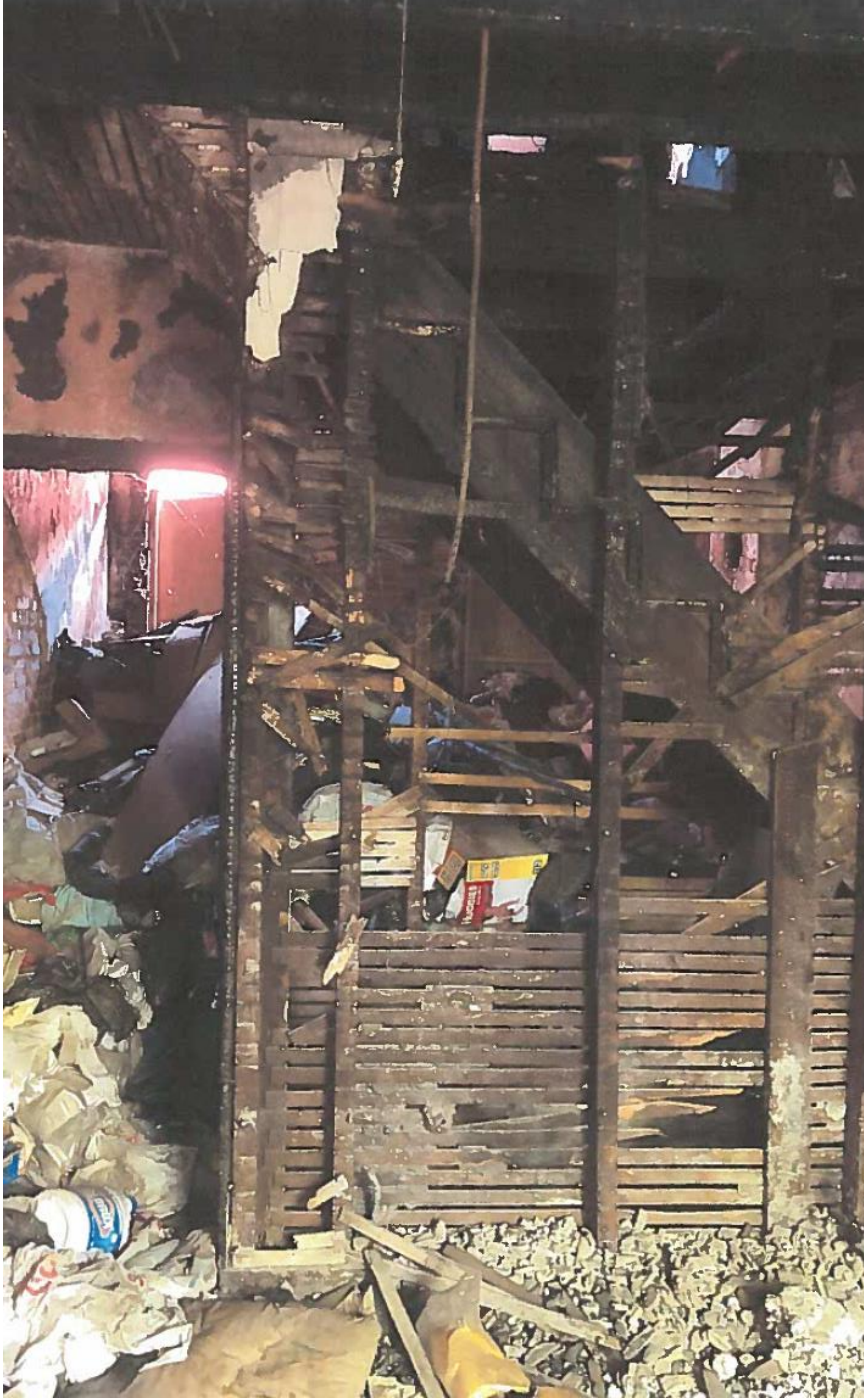
The applicant provided interior photographs of the building (*Images 19-21*). The applicant also provided a statement from James D. Plowden, Jr. PE, Principal of Plowden Engineering which reads in part:

Image 19: 1327 Booth Street – first floor interior, June 2018.

1. Temporarily brace the existing walls until the new framing is complete and properly tied to the walls.

2. Repoint the masonry inside and out. Replace any damaged brick. Place steel such as brick ties in the horizontal joists of the bricks (@ 16" o/c vertically) at any vertical or stair step cracks. Remove the parging and the vegetation for closer review.
 3. Replace the floors and roof with new framing. Provide a positive tie to the exterior walls.
 4. The steps are slightly separated from the building. I recommend replacing them.
 5. I suspect there is no waterproofing on the foundation walls. The basement walls should be checked for structural soundness. If waterproofing is needed, placing it may be difficult, especially on the east side, since this appears adjacent to the 1324 property.
- James D. Plowden, Jr. PE, May 23, 2018

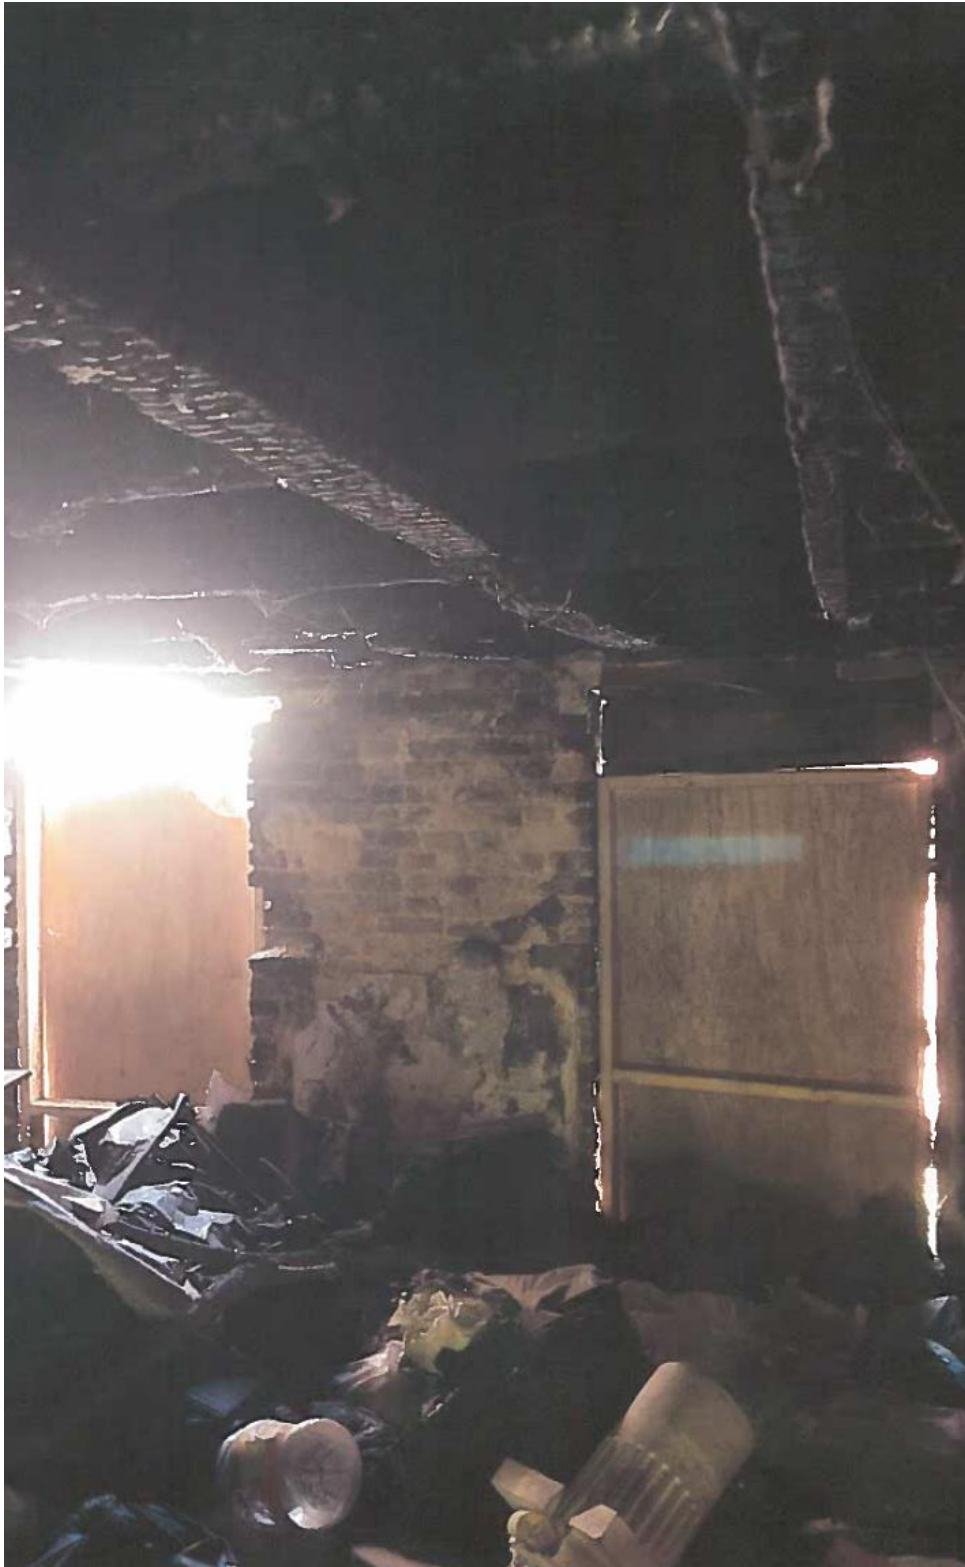
Image 20: 1327 Booth Street – interior, June 2018

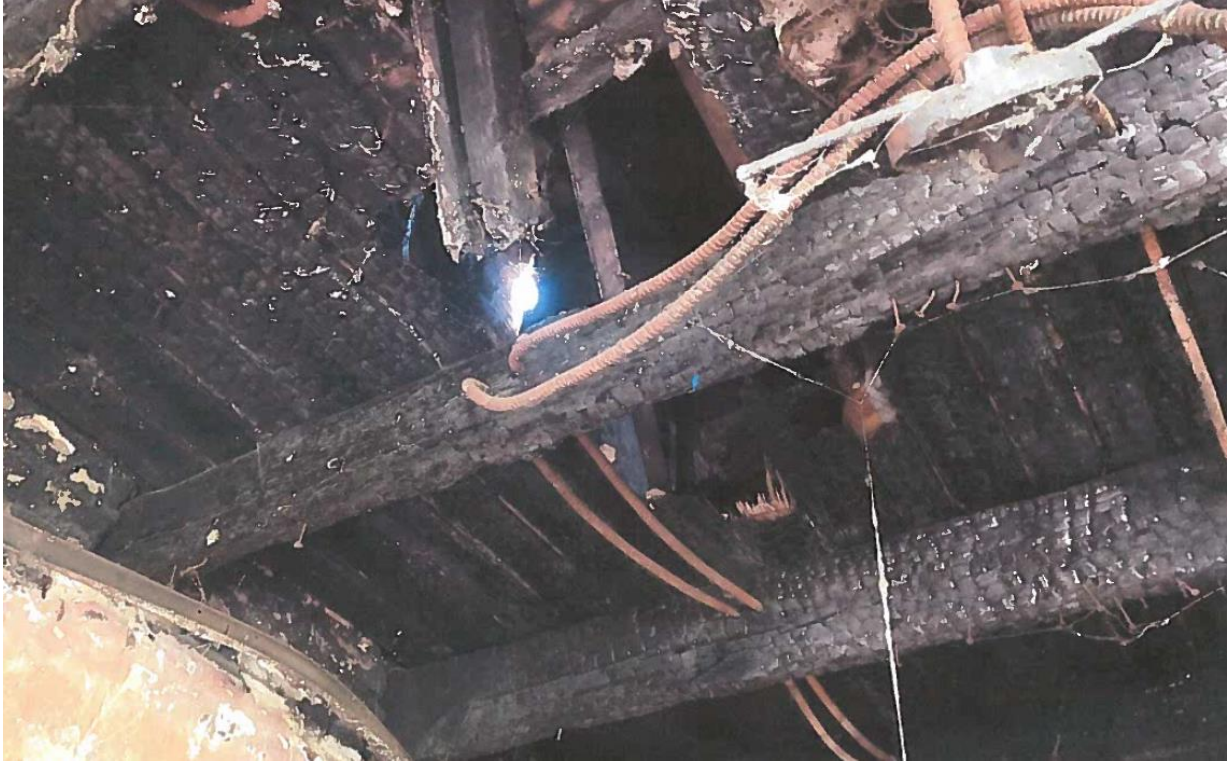
Image 21: 1327 Booth Street – interior, June 2018
